Manhole Inspection Summary

Manhole # S29YY_044MH

Insp Date: **10/9/08 2:12 PM**

Location Address: **GILMAN TER**

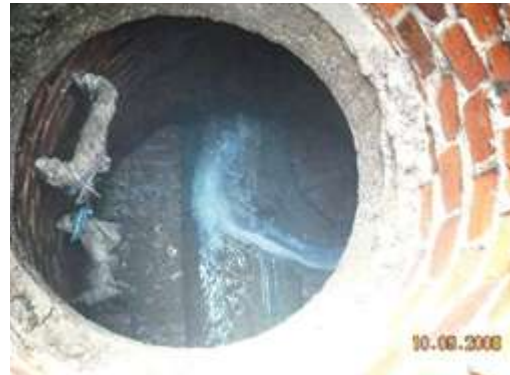
Top View

☒ **Debris** (not Condition related)

☒ **Evidence Of Surcharge**

Depth: **4.5** (ft.)

Evidence of surcharge - Bench debris.

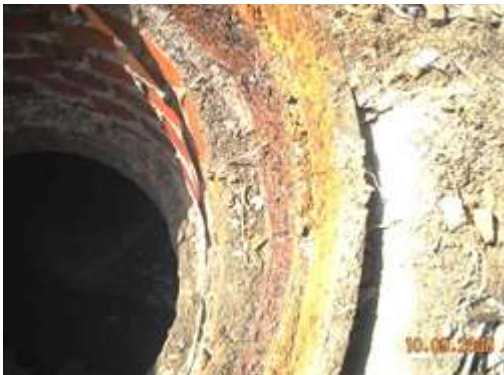
Defect

Offset: **2** (in.)

☒ **Leaks**

Infiltration: ☐ None ☒ **Joint** ☐ Cracks ☒ **Mortar** ☐ Roots ☐ Wall

Infiltration: ☐ None ☐ Joint ☐ Cracks ☒ **Mortar** ☐ Roots ☒ **Wall**

Frame leaks. Frame offset. Adjustment, Corbel and Barrel infiltration.

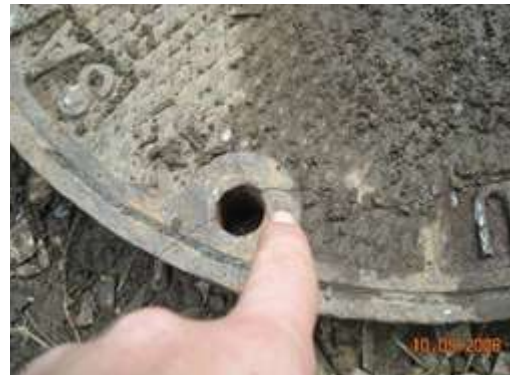
Defect

Condition: **Cracked**

Cracked cover.

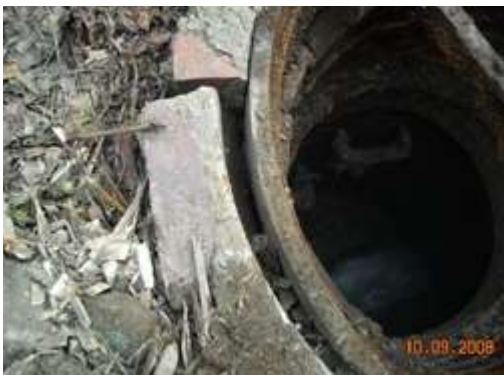
Defect

Frame leaks.

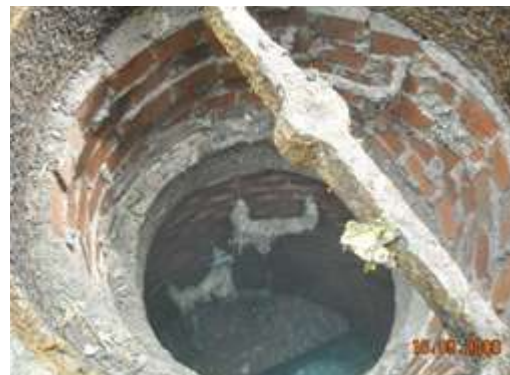
Defect

Condition: ☐ Sound ☐ Cracked ☐ Root Intrusion ☐ Loose Brick ☒ **Deteriorated**

Adjustment deterioration and infiltration. Corbel and Barrel infiltration.

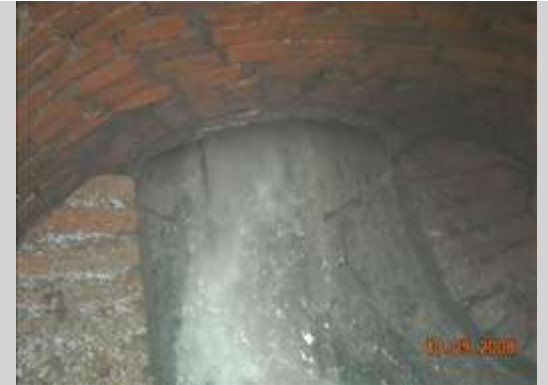
21 in. Circular Gravity Sewer Pipe Out @ 12 O'Clock

Infiltration: **Evidence** Pipe Seal Cond: **Unknown**
